CRITIQUE MINUTES - NONNUCLEAR  
COVERSHEET

**Bldg 225 (Plating Shop) chrome ventilation scrubber system**

**Release of contaminated fluid (chrome contamination) from Bldg 225 chrome ventilation scrubber fan.**

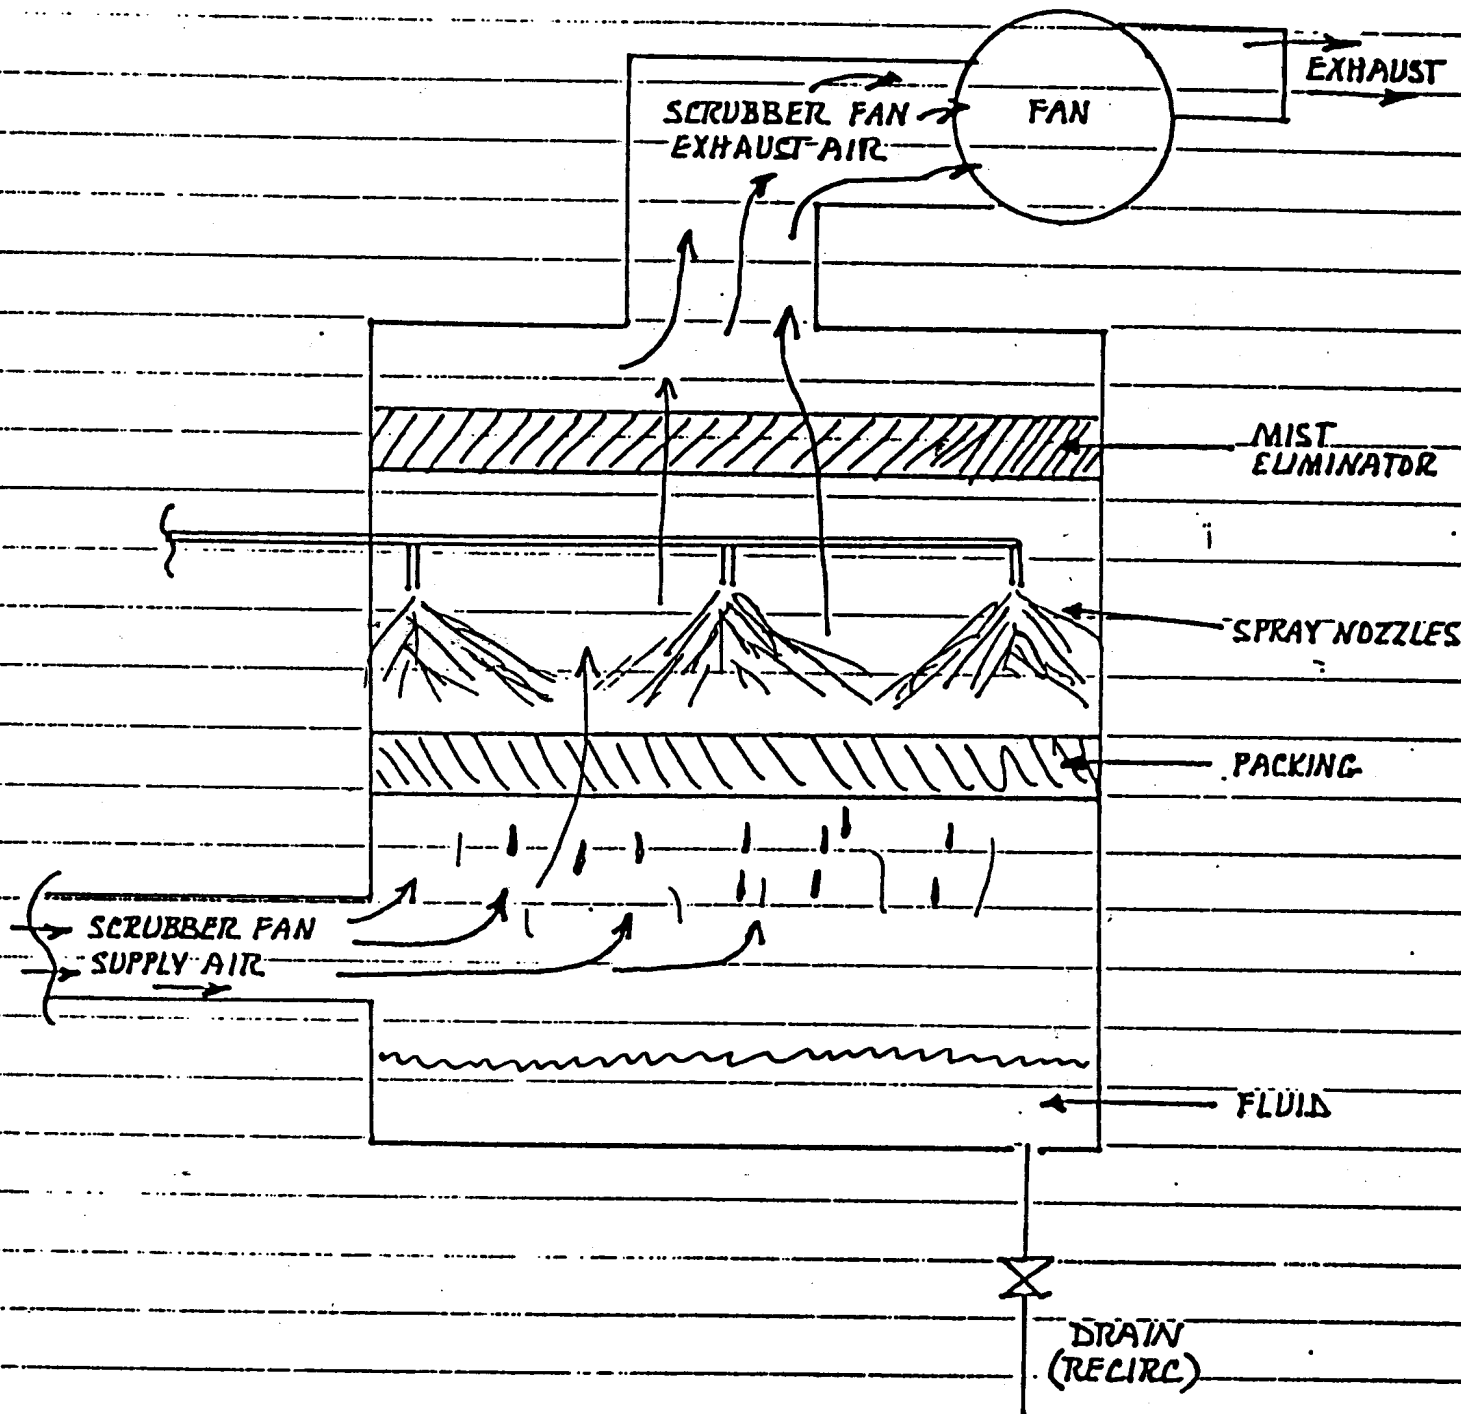
SIMPLIFIED SCRUBBER

a). Lack of Preventive Maintenance on the scrubber packing resulted in the buildup of chemicals in the scrubber packing which partially plugged them and reduced their ability to pass fluids. This resulted in an excessive liquid carryover through the scrubber fan.

b). Possible saturation of the mist eliminators with fluid which resulted in the fluid being sucked through the mist eliminator and blown out through the scrubber fan exhaust.

(Simplified scrubber drawing shown on attached)
